Safe use of bed rails

MHRA has produced the Device Bulletin DB 2006(06) *Safe use of bed rails*. Contact us on 020 7084 3272 if you require copies or visit www.mhra.gov.uk. Please report problems with assistive technology products online, via the MHRA website www.mhra.gov.uk or e-mail: aic@mhra.gsi.gov.uk

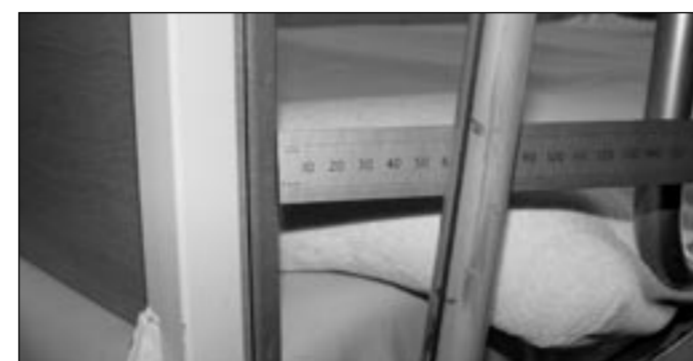
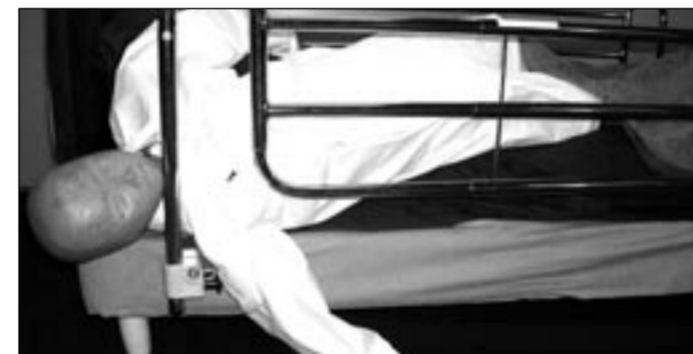
'Third party' bed rails, as photographed below, are not model specific and fit a wide range of beds. These are involved in most adverse incidents reported to us

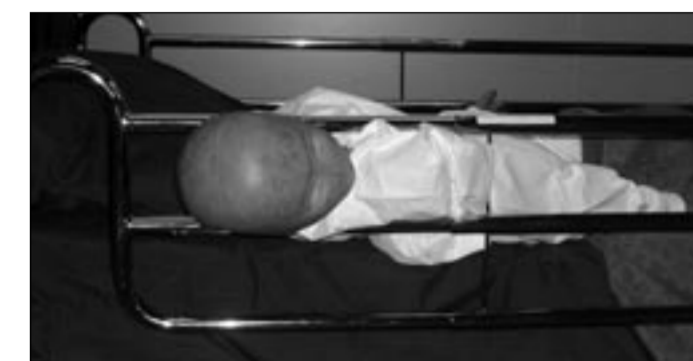
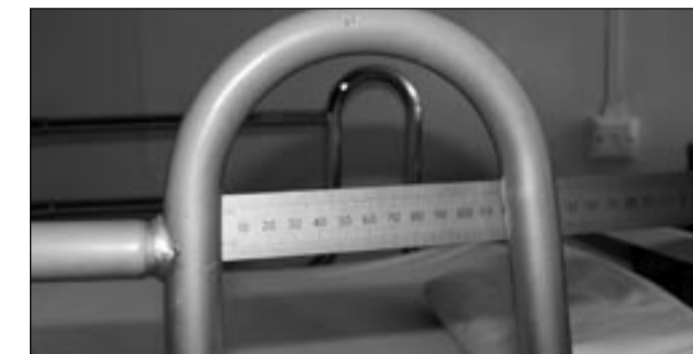
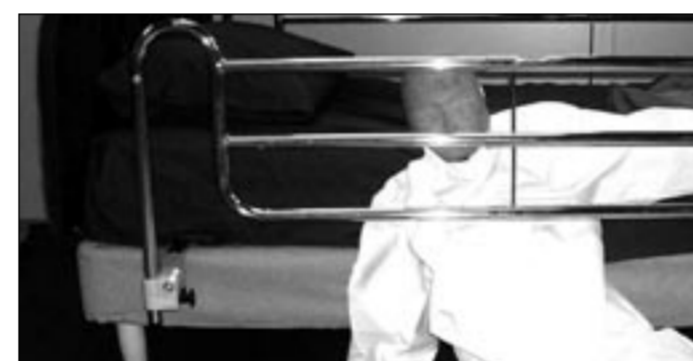
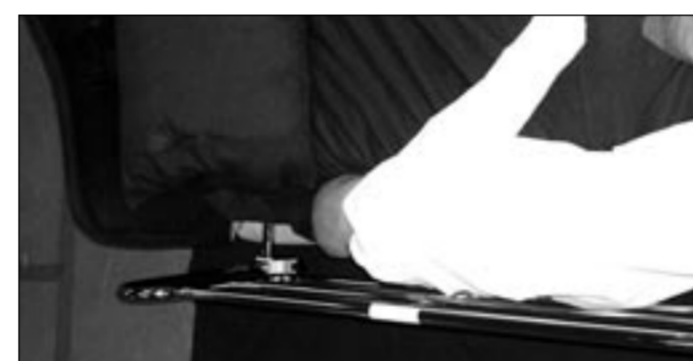
Design safety

For use with adults:

Bed rails should be fitted so that the gap between their end and the headboard is less than 60mm or greater than 250mm.

All gaps between the rail bars must be 120mm or less.

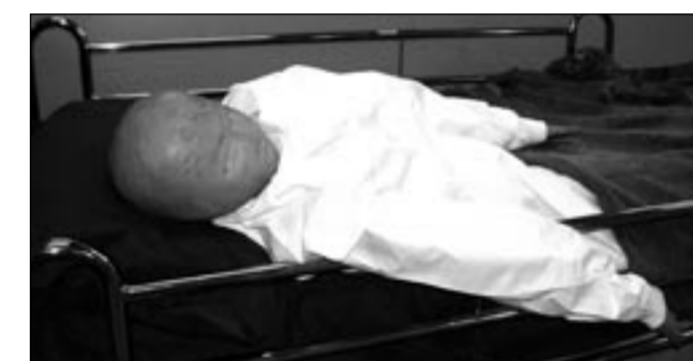
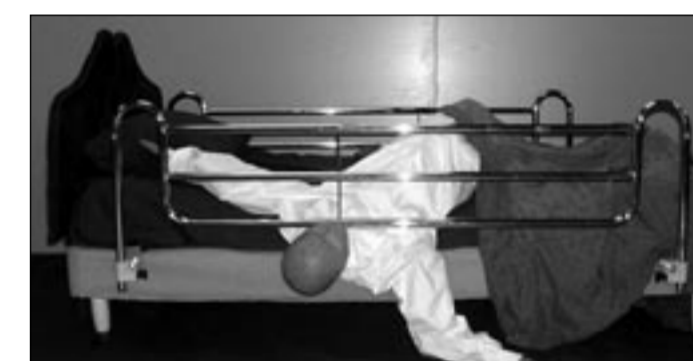
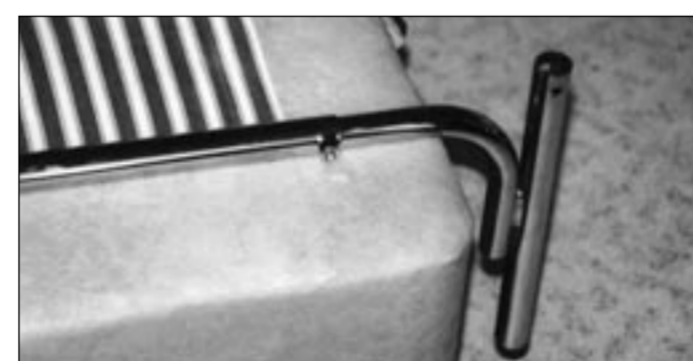
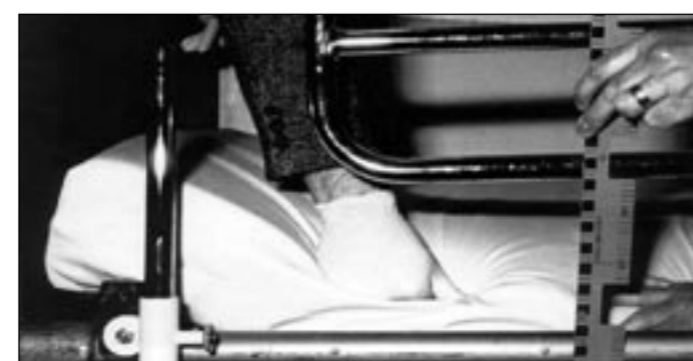
Hazardous positions

Most of the deaths caused by bed rails could have been avoided if thorough risk assessments of the bed occupant and the bed rail had been carried out.

MHRA investigations have also shown that many serious and fatal incidents with bed rails have been caused by a *lack of maintenance*.

Bed rails must be *inspected* on a regular basis to ensure they are in good condition.

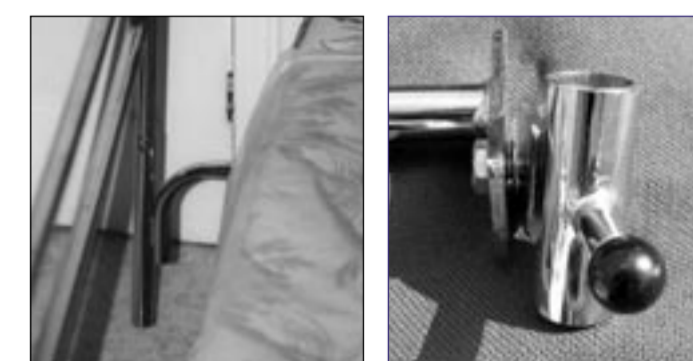
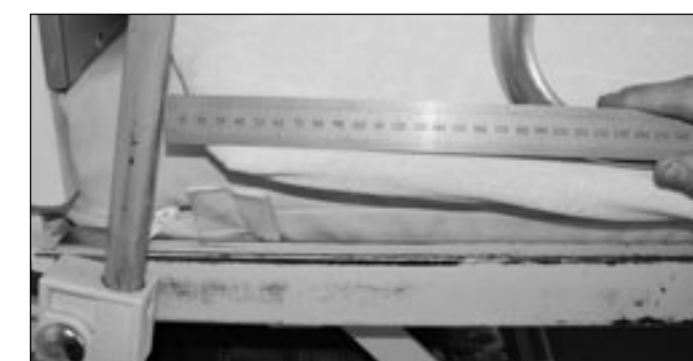
Things to avoid

- Gaps that could cause head, neck or chest entrapment between the end of the bed rail and the headboard or footboard.
- Using bed rails designed for divan beds on wooden or metal bedsteads.
- Using insecure fittings that let the bed rail move away from the side of the bed.
- Using bed rails that have not been maintained regularly.
- Bed rails with parts missing.
